Comments for the U.S. Treasury and Internal Revenue Service's (IRS) proposed regulations related to the 45V Credit for Production of Clean Hydrogen; Section 48(a)(15) Election To Treat Clean Hydrogen Production Facilities as Energy Property Docket REG-117631-23

Submitted by: Industrious Labs

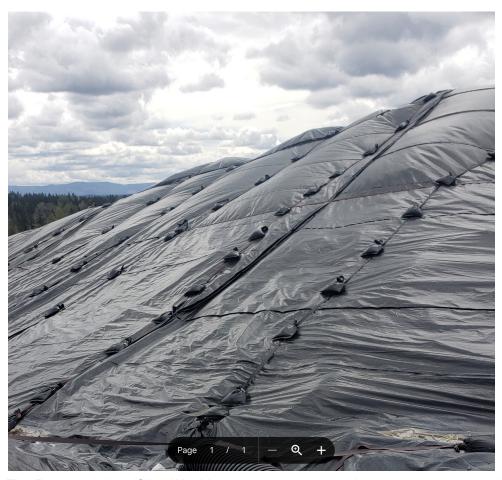
Image A: LRI 304th Street Landfill: Tarp edge by culvert, sections showing inflation at top: 9,000 methane ppm reading found (reading taken at 1' in air), strong odor¹⁵

Image A reproduces one of many photographs included in the LRI 304th Street Landfill inspection report, showing both the gas inflation of the tarp and the location of an impressively large methane exceedance.

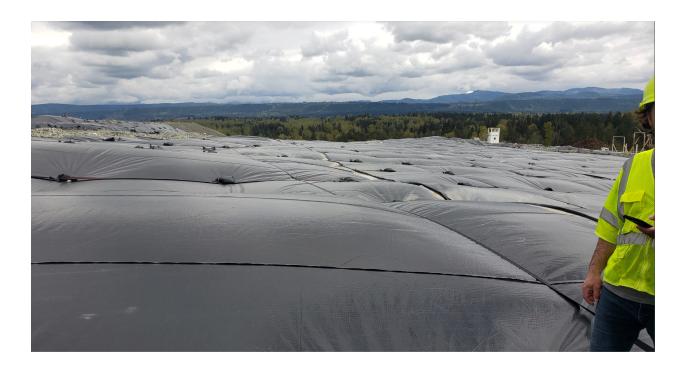
Image B: Roosevelt Landfill: Tarped area visibly inflated with landfill gas¹⁸

The Roosevelt Landfill in Washington reported no methane exceedances, while the EPA reported sixteen, many significantly higher than the exceedance limit. As the EPA inspection report states, "despite Republic having never found any SEM exceedances in its past 5 years of quarterly monitoring, including a full year of checking all penetration points, EPA identified sixteen points in exceedance of 500 ppm, including five points above 10,000 ppm, indicating potential concerns with Republic's SEM/Method 21 procedures. Image B reproduces one of the EPA Inspection photographs, showing the landfill gas inflating a tarped area.
